5 August 2002

My Notes; Replacement Family Housing, Ft. Wainwright, AK, DACA85-01-C-0026
Osborne Construction Inc.
Accident Fall From Height.

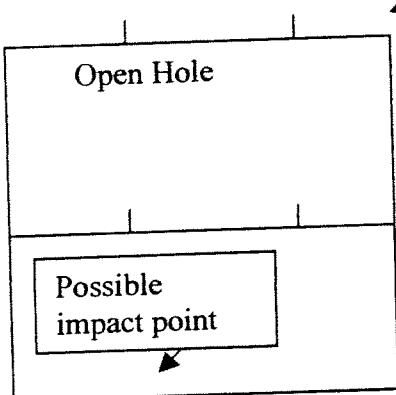
Possible impact, Scuff Mark

Anchor point 2" from hole

Anchor Point 12"
from edge and 18"
from opening.

Louis _____ and _____ Sollez indicated that they found the employee in this approximate position in the basement.

Employee working on edge of roof.

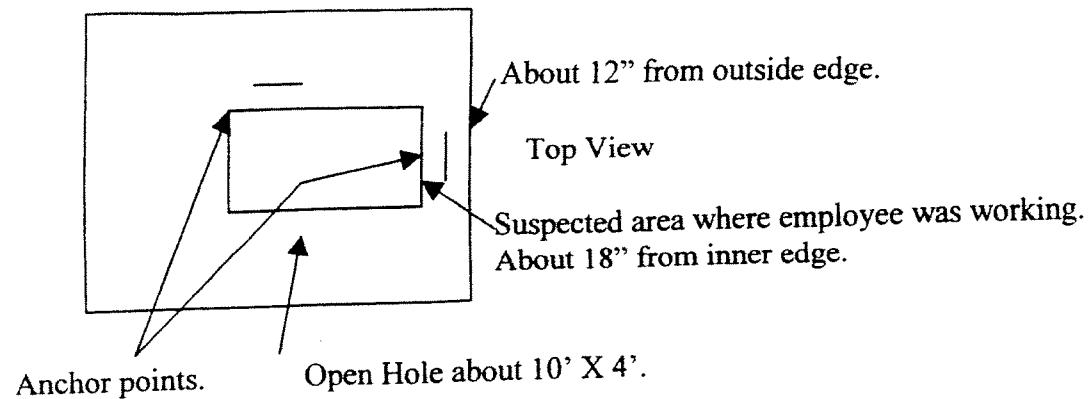
Side View

Initial indication are that the employee was working to remove an anchor point that was only 1 foot away from the edge of the rooftop. With an open hole about 18" behind him.

That the employee was removing the anchor point with a claw hammer, hammer slipped and employee went over backwards into the open hole on the rooftop. There were claw marks around the anchor point and the anchor point was about $\frac{1}{2}$ ripped out.

18 '6" to basement.
